Findings of the safety inspections found on the TEN-T road network in the Czech Republic

Jiri Carsky^{1,*}, Adela Johanidesova¹, Josef Kocourek¹

Abstract: In 2015 the Czech Technical University in Prague carried out a safety inspection on the TEN-T road network in the Czech Republic and on the selected 1st class roads (in the future they are intended to replace the planned TEN-T network). This article is designed to provide a basic overview of the most common problems in terms of both the frequency with which these risks occur and their significance. This article will also present a newly developed web application, CEBASS, which gives road operators an effective and systematic tool to manage the process of solving these problems. The aim of this article is to describe the classification created and used during the safety inspection course, which is better for road operators than the existing methods for safety inspections.

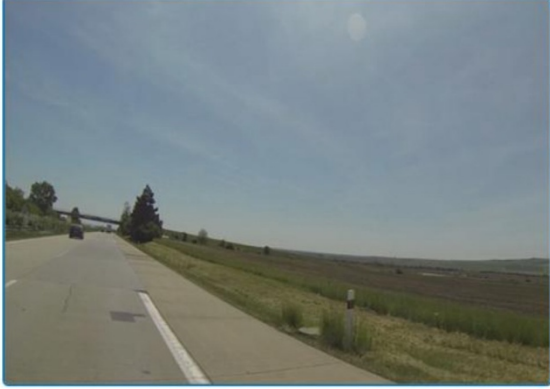
Road type and number → **D2 - P | km 33 - 34 | ID 19173** ← ID of road safety problem

ROAD SAFETY PROBLEM
Link (section) between junctions

CATEGORY OF PROBLEM
Absence and worn down of road marking
Notice: Absence of road marking in length of 180 m

SEVERITY OF RISK **LOW**

LOCATION
GPS: N: 48° 53' 37.17"
E: 16° 48' 01.47"
Stationing (chaining): km 33 - 34
Location: Road in rural area
Responsible administrator (Organization): SSÚD 7 Provodín
Speed limit: 130 km/h

Implemented measure: Correction of road marking
Notice: Realization of road marking type V2a and v4
Difficulty of realization: **SIMPLE**

Current phase → **Removed**

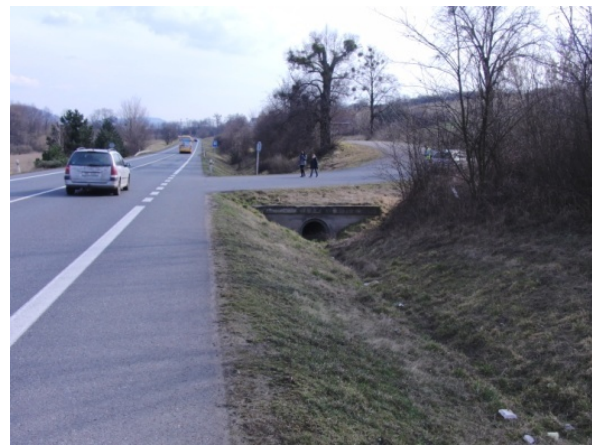
Figure 2 shows that the fourth most common problem (occurring 755 times) is culvert headwall located underneath an exit or in a separate exit. The group of authors has drawn attention to this problem. Using the knowledge and experience gained from previous research [4], systematic solutions to this problem are available. Examination and evaluation of individual exits shows that some exits no longer fit for its purpose and they have been neither maintained or repaired (structural defects were found in 35% of all exits, e.g. portals are still damaged several years after an accident). When regenerating roads, the non-functioning and non-authorized exits ought to be removed. Example of water drains can be found in Figure 5.

Fig. 5 Rigid culvert headwall (1st class road I/52, km 34 - 35).

From the point of view of construction work, the embankment crown retainers should also be optimized. This is one of the ways in which the biomechanical injuries of passengers can be minimized. This likelihood, which is closely associated with a front-on impact (the headwall), can be minimized by changing the gradient of the culvert headwall. This innovative solution has been implemented even though experts have no valid studies on the effect of these sloping culvert headwalls on the way in which a vehicle moves during and after an accident. This is an empirically established potential solution for improving safety. It would be advisable to undertake a study to verify the positive contribution this change brings. Any potential research should not focus just on traffic accidents

The second new solution is integrated shock absorbers. The idea would be to have separate exits that already contain individual deformation blocks. The deformation blocks are able to withstand load transmission from vehicles (in a vertical direction) and are designed to deform in the event of side-on impact. Last but not least, it goes without saying that other more – or less – conventional solutions can also be investigated, such as preceding the shock absorbers (to absorb the mechanical energy of a crashing vehicle) or restraint systems (concrete or steel guard-rails).

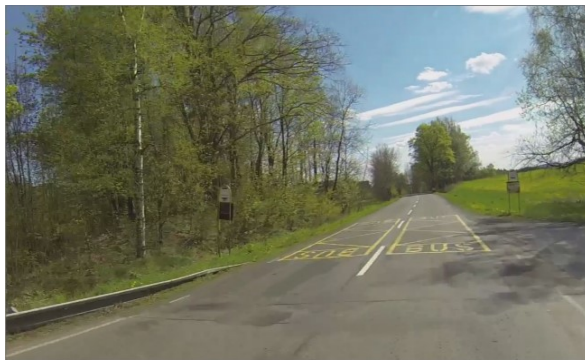
The last two subcategories are essentially the most risky. The following figures show the standard bus stop designed on rural roads in the primary road network of the Czech Republic. Figure 6 shows example of bus stop.

Fig. 6 Bus stop (1st class road I/16, km 189 – 188).

- develop bus stops that encourage people to use public transport, improve comfort and increase road safety;
- avoid upgrading bus stops on the traffic lane and use this solution as a special option in justifiable cases only;
- carry out a detailed assessment of the location of bus stops on rural roads from the point of view of routing; compare this with the routes for road users not driving motor vehicles who could be injured.
